## IMAGERY SECTION

Additional images are provided below of the sampling points 1-3 (Figure 1), the microscope images at each point and the google area imagery. This section further illustrates that visually the limestone can be easily traced through google area imagery.

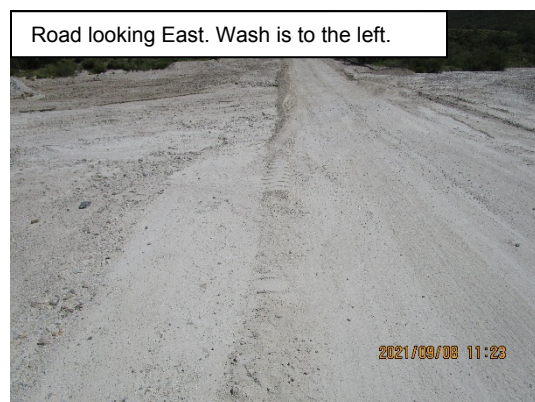
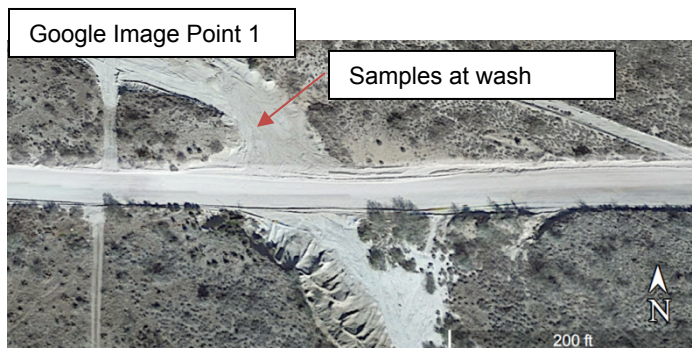
### Point 1

Google map indicates most of this area has a top layer of limestone from the Imerys quarry (quarry is less than 1 mile away). Site picture confirms the area is covered with limestone residue.

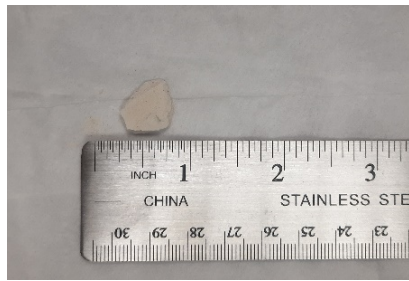
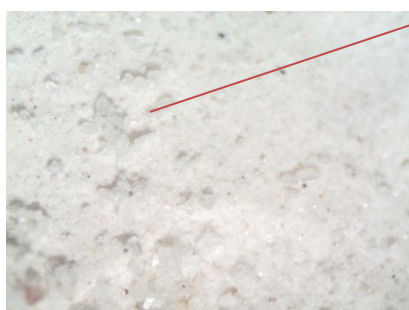
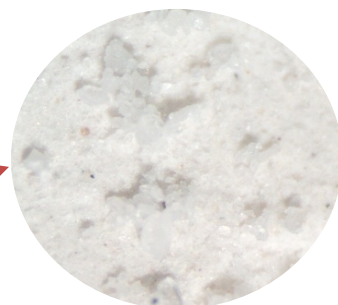
#### Solid Sample

Magnification similar to stalagmite.

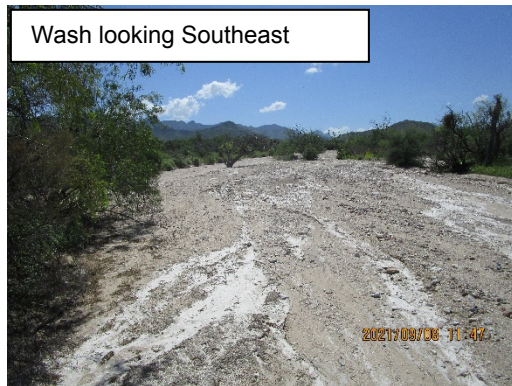
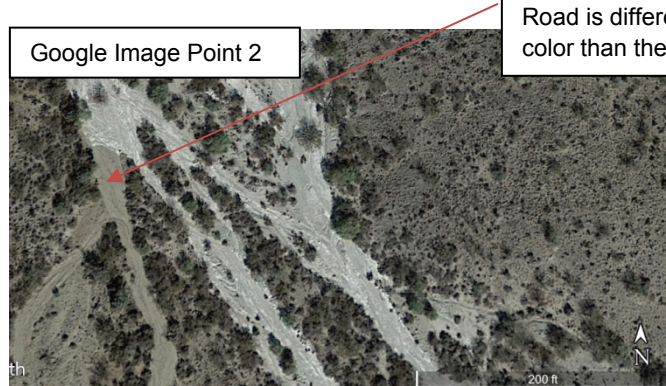
## Point 2

Site Picture confirms the visual white residue from google map. The picture to the right is the road going into the wash and is darker than the white patches.

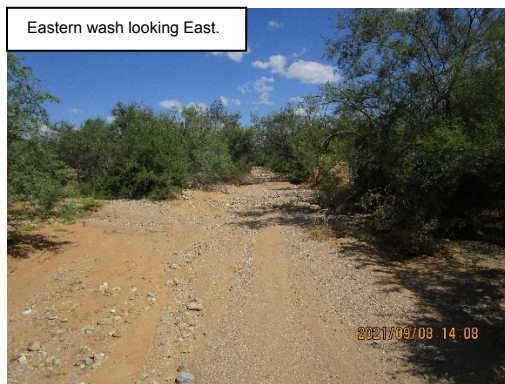
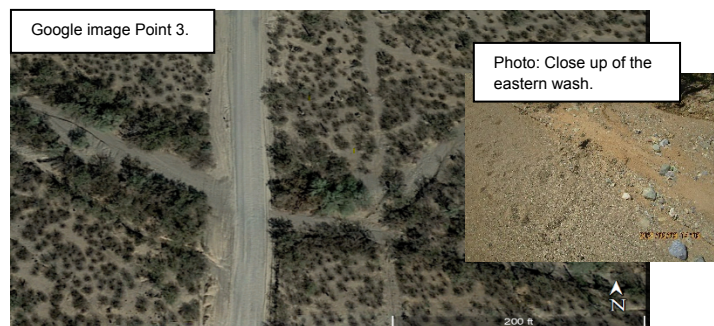
### Point 3

Site Picture confirms there are no visual white residue from google map. The picture to the right is the typical soil sediment seen in the area washes.
